## Editorial

## REPORTS ...

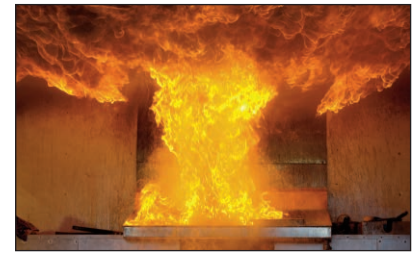
A casserole containing oil was left unattended in the oven or on the range; oil leaked through small holes at the side.

In this case an unattended leaking casserole represented a long term hazard, indicating a poor sense of hygiene and awareness of risk.

Galleys are high risk areas. Power should be switched off at the end of each use, whenever the galley is left unattended, and at the end of each working day. The fitting of external galley power breakers which do not require entry to galley spaces is a wise additional precaution.

Maintain **particular vigilance in galleys**, and invariably include them in rounds routines by day and night.

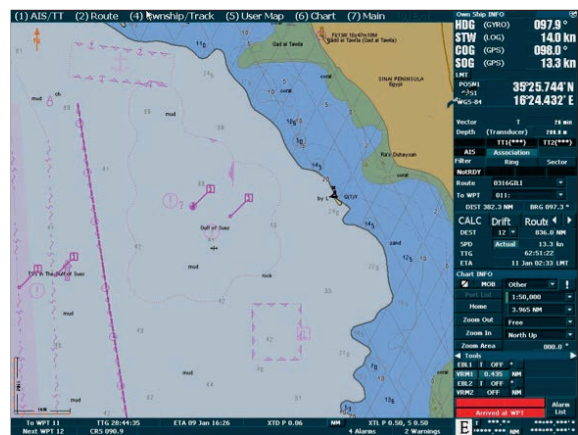
During preparation of a passage plan for a forthcoming voyage, it was observed that one chart did not show all the information that had been seen when passing through the Suez Canal previously. There emerged considerable confusion on the source, date and identity of the right chart within the ship’s system. Space prevents detailed coverage. Eventually the correct electronic chart was identified by the ship’s provider, and supplied.

One supplier’s chart

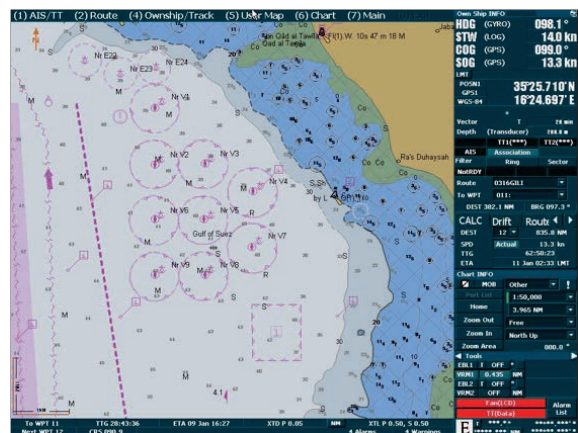
Another supplier’s chart

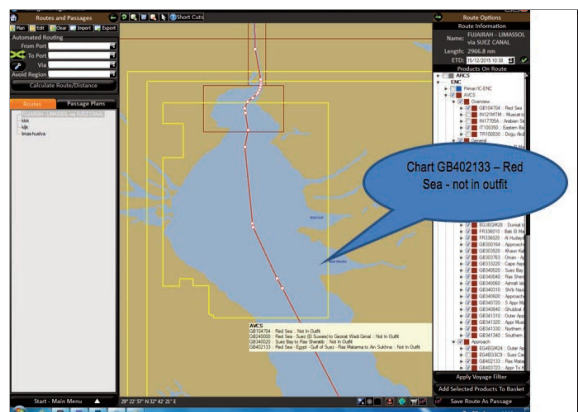
The Passage Manager page

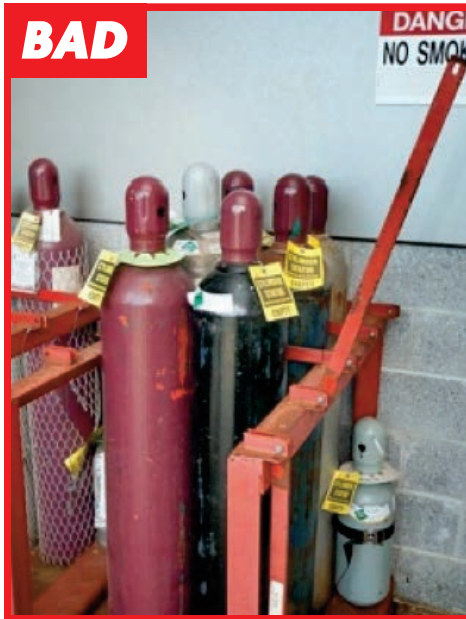
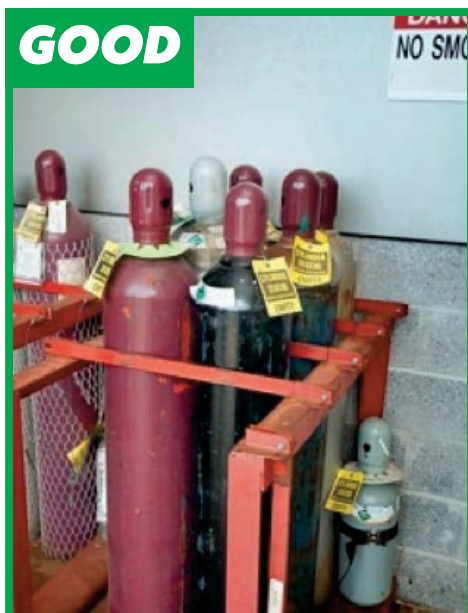
In **CASE 1**, a bulldog grip U bolt had slipped out of position on a lifeboat lashing. It was found that the grips were fitted incorrectly, and had also been subjected to wear and tear over a period of time.

In **CASE 3**, the boom of a main deck crane was heaved up, without taking out the securing turnbuckle, from the rest stand. This caused deformation to the plate to which the lug had been welded.

In **CASE 4**, oxygen and acetylene cylinders were not properly stowed and secured, and were about to fall onto the deck.

In **CASE 1**, routine inspections had been ineffective: the bulldog grip slipped, and had been incorrectly fitted. Wear and tear was evident.

In **CASE 3**, improper preparation, haste, and inadequate supervision were the probable causes. Every lifting operation using the ship's crane should **apply good seamanship practices, be properly planned within the prevailing conditions, and be appropriately supervised** by a competent officer. The lifting appliance should be operated by a competent, well trained crew member.

- With respect to the bulldog grips, vibration can be another cause of wear and tear. The UK MCA specifically discourages their use in Annex 18.2 of the UKCOSWP 2015, and prohibits fitting to lifeboat falls and lashings; similarly for rescue boats and liferaft lifting gear. Would you trust your life to incorrectly fitted wires?

- Working with any chemical requires proper planning including the use of the Material Hazard Data Sheets that are supplied with chemicals.
- For the crane boom incident, this is down to planning and supervision. The crane operator should respond only to the supervisor who should be using correct signalling techniques. UKCOSWP 2015 19.9 and 19.11.1 refers.
