Editorial

Reports

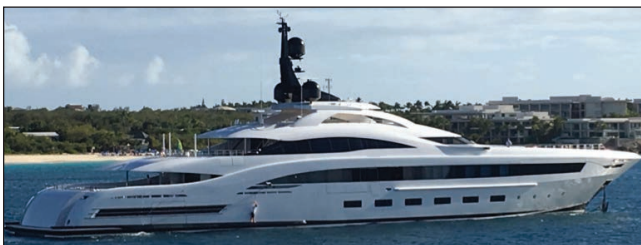
A crew member was seen on the starboard side standing on a ledge just above the waterline with no lifejacket or safety harness visible; he was hanging on to a single line from above. He balanced there for some time, before jumping into the sea and swimming up to the bow. He then climbed onto the anchor. The foredeck crew then continued raising the anchor whilst the man was busily working to clear the fouled rope.

Note man on starboard quarter platform

The hazards are clear. A particularly serious one is entanglement in the fouled line while the man was attempting to clear it from the anchor to which he himself was clinging. It is not obvious whether the line was under tension or whether it was light or heavy. However a sudden increase or release in tension could have had the man trapped under water or potentially towed astern near the propellers. The vessel was operating propulsion at the time. It is not clear whether the man on the anchor was continuously supervised or not. He certainly should have been; it is very unlikely that he was visible from the bridge. He was not wearing a life jacket and did not have a lifeline/harness other than the line onto which it is reported he was hanging. These are severe safety lapses.

Maintain professional standards; this depends on **safety culture** which itself in turn depends on the lead given by the Master and officers. Carry out a **risk assessment** and briefing before taking action in unusual circumstances; these may be short and crisp if need be, provided they are considered and conducted against a check-list (see above). **Guard against cutting corners** when the atmosphere is relaxed. **Remember key safety principles:** for example the wearing of life jackets always in exposed places, life lines, provision of a safety boat and supervision of risky work. **Remember ubiquitous risks at sea:** for example lines under tension, drowning.

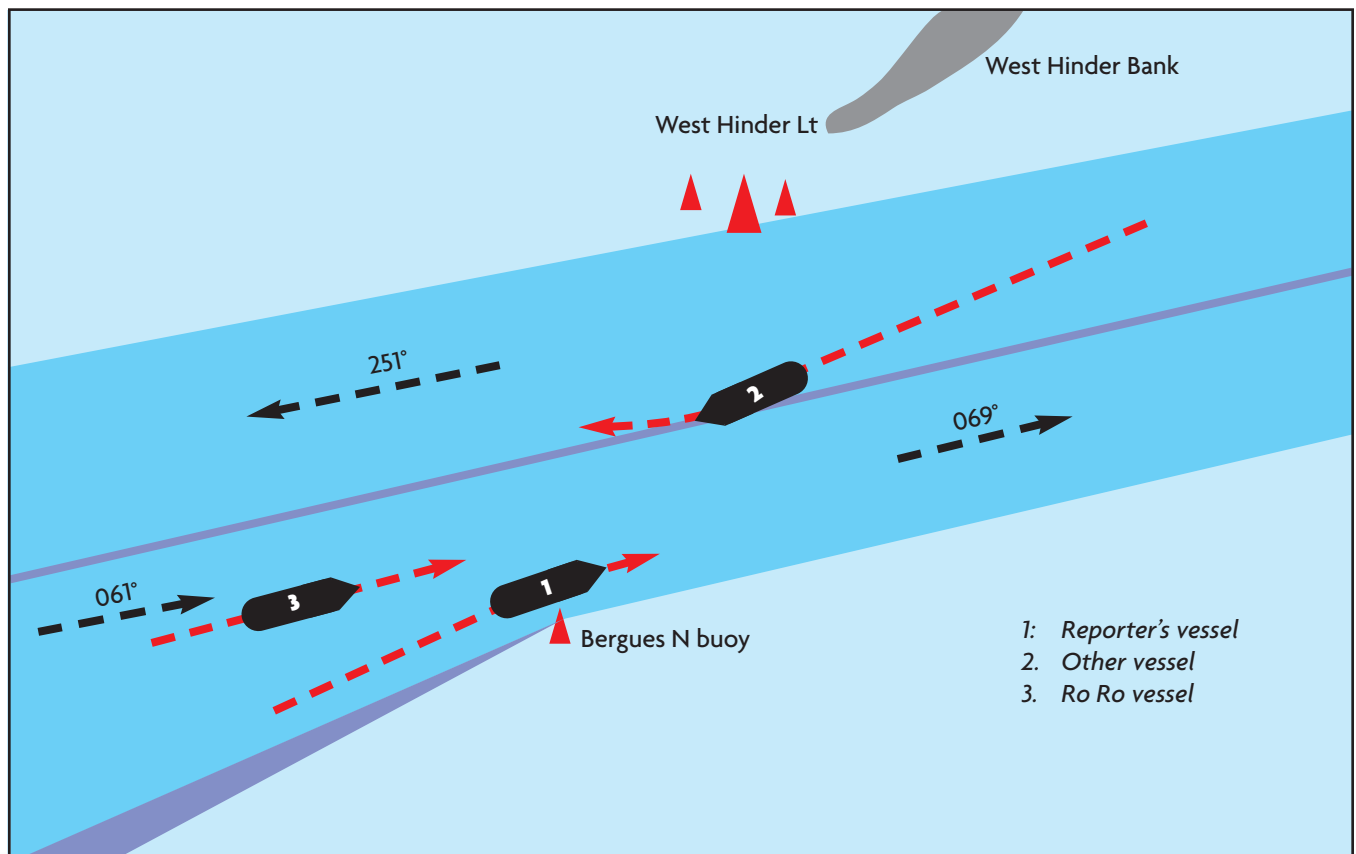
At approaches to Westhinder, ship 2 in the sketch was observed in the SW lane off Westhinder light tower. Own vessel was proceeding in the opposite direction in NE lane, passing close to Bergues North buoy, being overtaken by a ro-ro ship (ship 3 in the sketch) on port quarter. [ship 2] was then observed turning slowly to port and crossing the dividing line into the NE lane with a CPA of 3 cables to own vessel and collision course with [ship 3 in the reporter's sketch]. I called on VHF 60, no answer ... eventually [place] approach contacted ship 2 on VHF16 asking what were his intentions and that VHF 60 must be monitored ... which then occurred, with [ship 2] turning back to starboard on the extreme edge of the separation scheme.

The reporter offered the view that ship 2 was not keeping a proper lookout, was not monitoring her position, and was in contravention of rule 10 (TSSs). She also failed to respond on the VTS channel for that sector and placed own vessel and another in a potentially dangerous situation. He noted that the standard of English was poor in VHF communication, that he (the reporter) was tightly constrained to starboard by the Bergues North buoy, and that visibility was good.

A highly dangerous situation arose; had ship 2 progressed any further before her alteration back to starboard into the south west lane, she would have been at very close quarters with ship 3, and quite possibly in collision. We see again how quickly such a situation can develop, especially in dense shipping and constrained waters. The danger is further exacerbated when the constriction of a TSS brings – in this case – three large vessels into close proximity with almost no sea room to spare: the “sandwich effect”.

Traffic separation Collision Regulations (COLREGS). Ship 2 certainly contravened COLREG 10(b)ii (“... keep clear separation line”) by encroaching on the separation line, and at least came close to contravening COLREG 10(b)i (“... general direction of traffic”).

Other COLREGS. She also failed to take ‘positive action in ample time’, and was probably failing to keep a proper lookout. These failures may well have been exacerbated by overload, tiredness, distraction, undermanning, and/or failure to look up and out. Obviating these risks must be part of the passage planning process and supervision at the time.

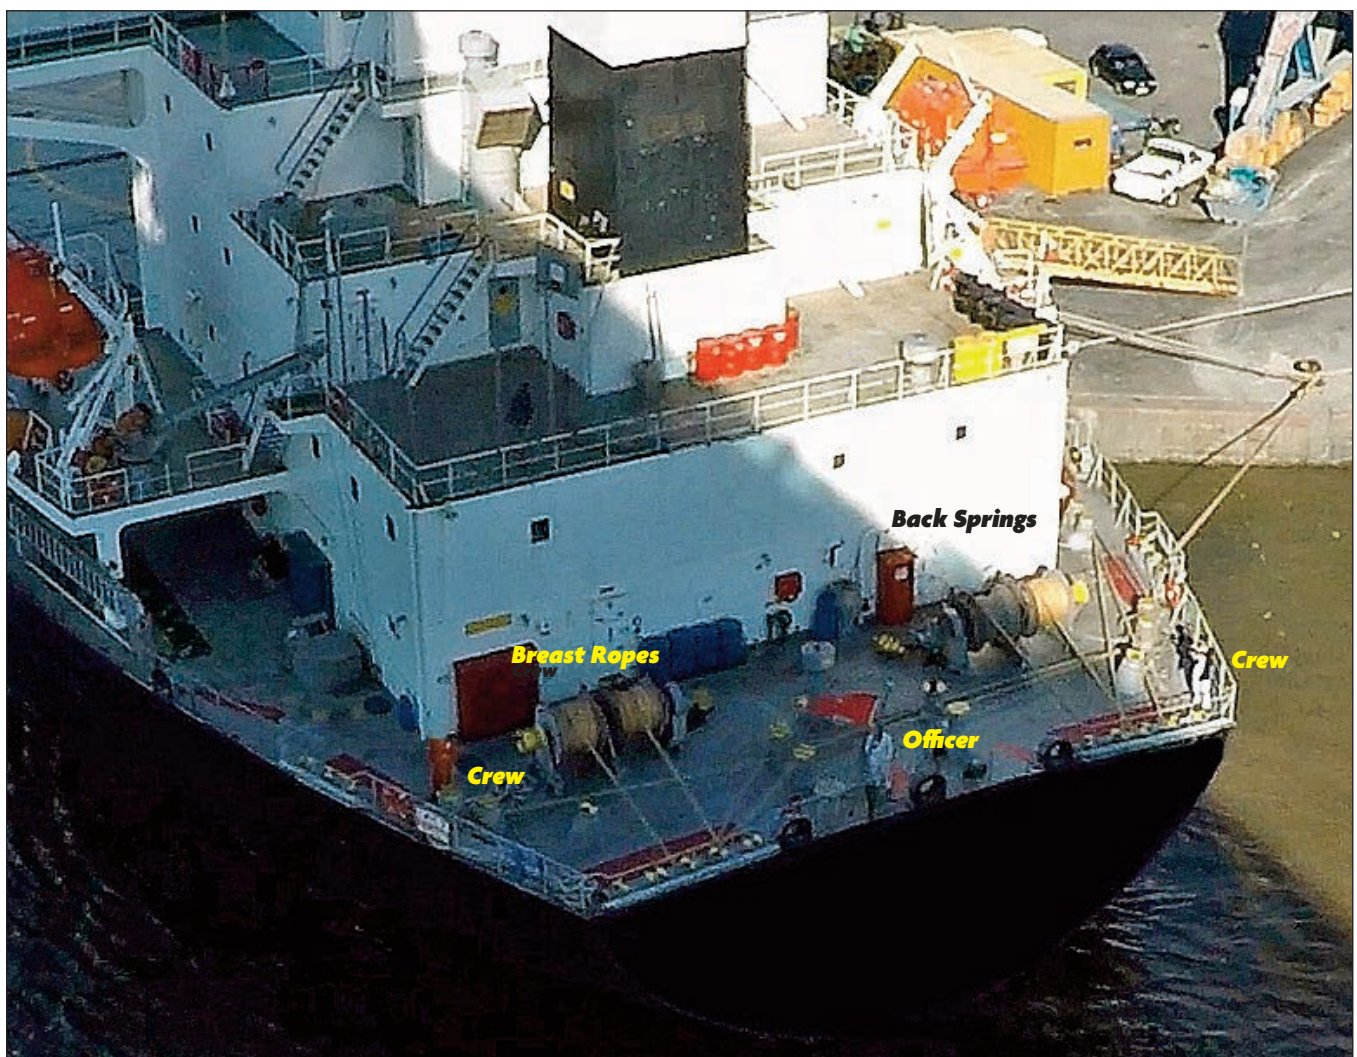
The moored vessel does not fit the berth since stern lines cannot be run and the back spring and breast lines have poor leads. This led to excessive strain being placed on the lines as the departing passenger vessels wake interacted with the moored vessel.

The design of the ship's after mooring station appears poor; mooring lines may be at greater risk of parting due to the angled leads and the need to use roller leads across the deck. In this case the mooring bollards have not been employed.

There is an apparent lack of general awareness; the officer and crew members had placed themselves within the after mooring ropes snap back zone at a time when the mooring lines were likely to come under surge load.

This is a good example of an inappropriate berth in relation to the size of vessel; it could have been refused. Ships' mooring arrangements are designed for conventional long leads forward and aft. The use of stern (and probably head) lines in reverse direction as shown greatly increases the stress on mooring arrangements, and encourages premature failure with obvious safety implications. In this case the passenger ship's manoeuvres at very close quarters may – through interaction and surge – have amplified the danger of mooring failure.

The whole mooring deck in this case is a “snap back zone” especially in such a confined area with multiple unconventional leads. Consideration may be given to identifying and marking alternative “tension spots”. These carefully considered relatively safe points for mooring parties to stand and operate will limit exposure to snap back and discipline crew to remain in sheltered areas to the maximum extent possible. Mooring lines may be subject to surge at any time; **roaming and unauthorised movement on working decks should be forbidden**. Roaming ‘safe areas’ may well not be safe all of the time; snap back zones will vary according to leads and circumstances. For further information see Maritime FEEDBACK number 39, page 2; Code of Safe Working Practices for Merchant Seamen (COSWP) section 26.6; and the article on this subject published in the November 2015 edition of the ‘Safety at Sea’ magazine.

Safe “tension spots”, training and mooring discipline represent a safer way forward in mooring practice.

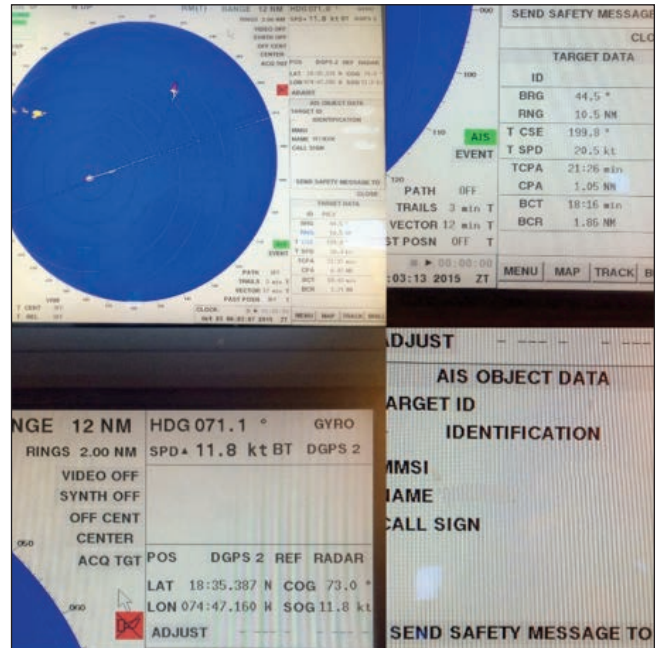
The reporter considered that the passenger ship's crossing ahead distance (around 2 nautical miles (nm)) and CPA (around 1 nautical mile) were too small; this is shown on the automatic radar plotting aid (ARPA) screen shot below. It depicts true vectors in this case.

ARPA screen shot; true vectors

It is proper that judgement ultimately lies with ships' Masters given all the circumstances. That said, a minimum 2 nm CPA in open water is widely accepted as good practice. In this case, with a crossing range ahead of 2 nm, the CPA on the starboard bow of the stand-on vessel was bound to be around 1 nautical mile. The stand-on vessel had every right to express concern; in this event, it was incumbent on the other to act accordingly and to give way, even if she considered the stand-on CPA safe. This action would also have been consistent with traditional good manners and respect between seafarers.

“If there is doubt, a risk of collision exists”. Thus it is incumbent on a ‘give-way’ vessel (and also a matter of good manners) in a crossing situation to alter if the stand-on vessel expresses concern. **Doubt is always accompanied by danger and risk of miscalculation.** Avoid use of VHF if possible; it can be a distraction from the correct actions when time is tight. Think from the point of view of the other ship; what may seem safe and reasonable to one may not from the other’s bridge. **Maintain the habit of constant ‘what-iffing’:** “what if my steering gear failed now”?
