CHIRP MARITIME FEEDBACK

Issue No: 38

01/2015

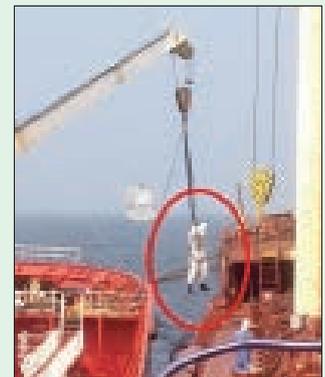
Report Text: Non-compliance with personnel transfer procedures during STS operations created an uncontrolled, high-risk transfer between vessels. There is a very clear explanation in the STS procedure booklet on how to carry out personnel transfers but the charterer and ship managers had earlier advised there will not be a surveyor, or any cargo inspection and therefore the daughter vessel did not have to acquire a Personnel Transfer Basket (PTB).

The transferred person was the supercargo working for Company "X". This was the first time working for them and he was afraid in case there were any mistakes in the calculation of cargo transferred. Despite the mother vessel's advice that no personnel transfer was required, he insisted on visiting the mother vessel.

The supercargo ignored all advice and despite every warning, he jumped across to the mother vessel using a safety harness on the ship's crane hook (like Tarzan)!

The Supercargo and the daughter vessel's crew were advised that this type of transfer is very dangerous.

CHIRP Comment: The report highlights a very dangerous practice. The pressure to visit the mother ship appears to have been solely due to the supercargo and perhaps in the belief he was creating a good impression on his first assignment. The result was a senior person flaunting safety standards on both ships. The safety culture on the ship operating the crane was not strong; the crew did not feel empowered to stop lifting the inspector when he insisted on the lift. The inspection company needs to review the procedures and requirements when personnel are transferring between the ships.

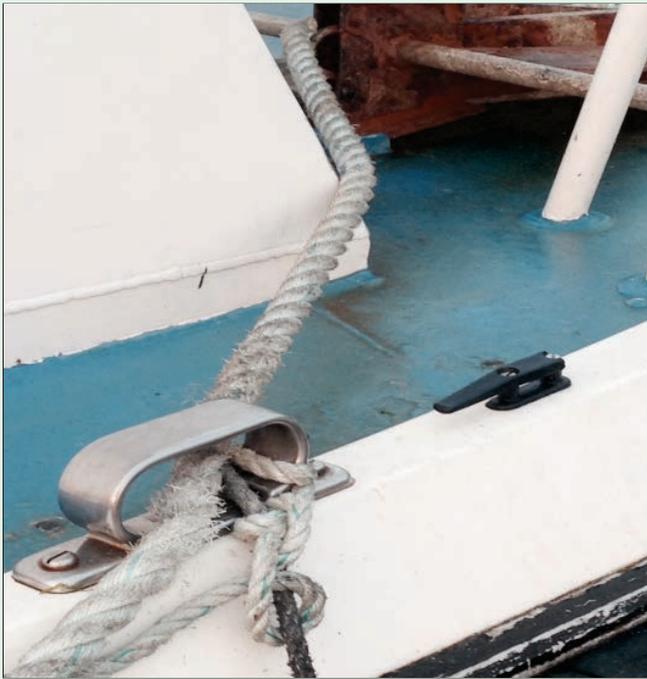
Prior to boarding one day, it was noted that the relief ferry was being secured to the slipway on the island using only a frayed bow line as a spring, the vessel being left powering against the spring while passengers disembarked and embarked.

The reporter's concern is that the rope might break, or the vessel might pull a ring out of the pier as considerable power is used to hold the vessel against the slipway, especially if the tide is ebbing hard, or a strong offshore breeze is present. The reporter's concerns are compounded by the fact that the skipper does not stay at the helm during loading and unloading. Of lesser concern is that no safety announcements are taking place, which is common on this route.

Lessons Learned: The crew could usefully be sent on a safety awareness course and then adequately supervised to ensure compliance with safety regulations.
