# CHIRP MARITIME FEEDBACK

Issue No: 35

02/2014

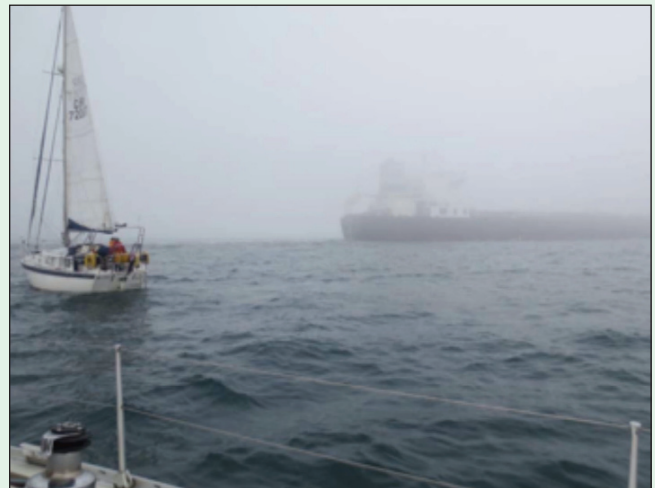
CL's radar was set with course up (not the more convenient north up) and so when we altered course all the tracks of radar contacts changed and in the next few minutes it was not clear if the true courses of any of the contacts had changed. However we felt confident that from the previous plot we should be safe. We then suddenly saw a large indistinct visual contact on our port beam at a range of two to three cables. At first we thought this was a ship heading west but after a few moments we saw a bow wave and realised it was a large ship heading straight for us. Seconds later the helmsman saw that we were very fine on the ship's starboard bow and altered course violently to port reversing our course from east to west, D following. A large, Chinese registered bulk carrier (BC) just passed us at a distance of less than 100 yards (see photo attached, taken from D). This was too close for comfort.

**Overview:** We had altered course from north to east to avoid the BC, which we had plotted as steering west. However as we came into close quarters she was steering south so she had clearly altered course. Our radar plotting on CL was not accurate enough to have seen this although on D they had just noticed this but did not have time to notify CL. It seems clear that BC had altered course to port and to a course of south at the same time as we had altered to a course of east. We had both altered from one set of converging courses to another at the same time!

It seems clear that BC had contravened this rule. CL's radar plotting was weak being 'head up'. This was perfectly adequate to cope with CL being on a steady course, but with 6–7 contacts and a major alteration of course, it proved inadequate. However CL/D complied with Rule 19 by altering course to starboard when we considered that a risk of collision existed whereas BC contravened Rule 19 by altering course to port for a vessel forward of the beam.
